FIGURE 7-4 OVERALL SCHEMATIC DIAGRAM

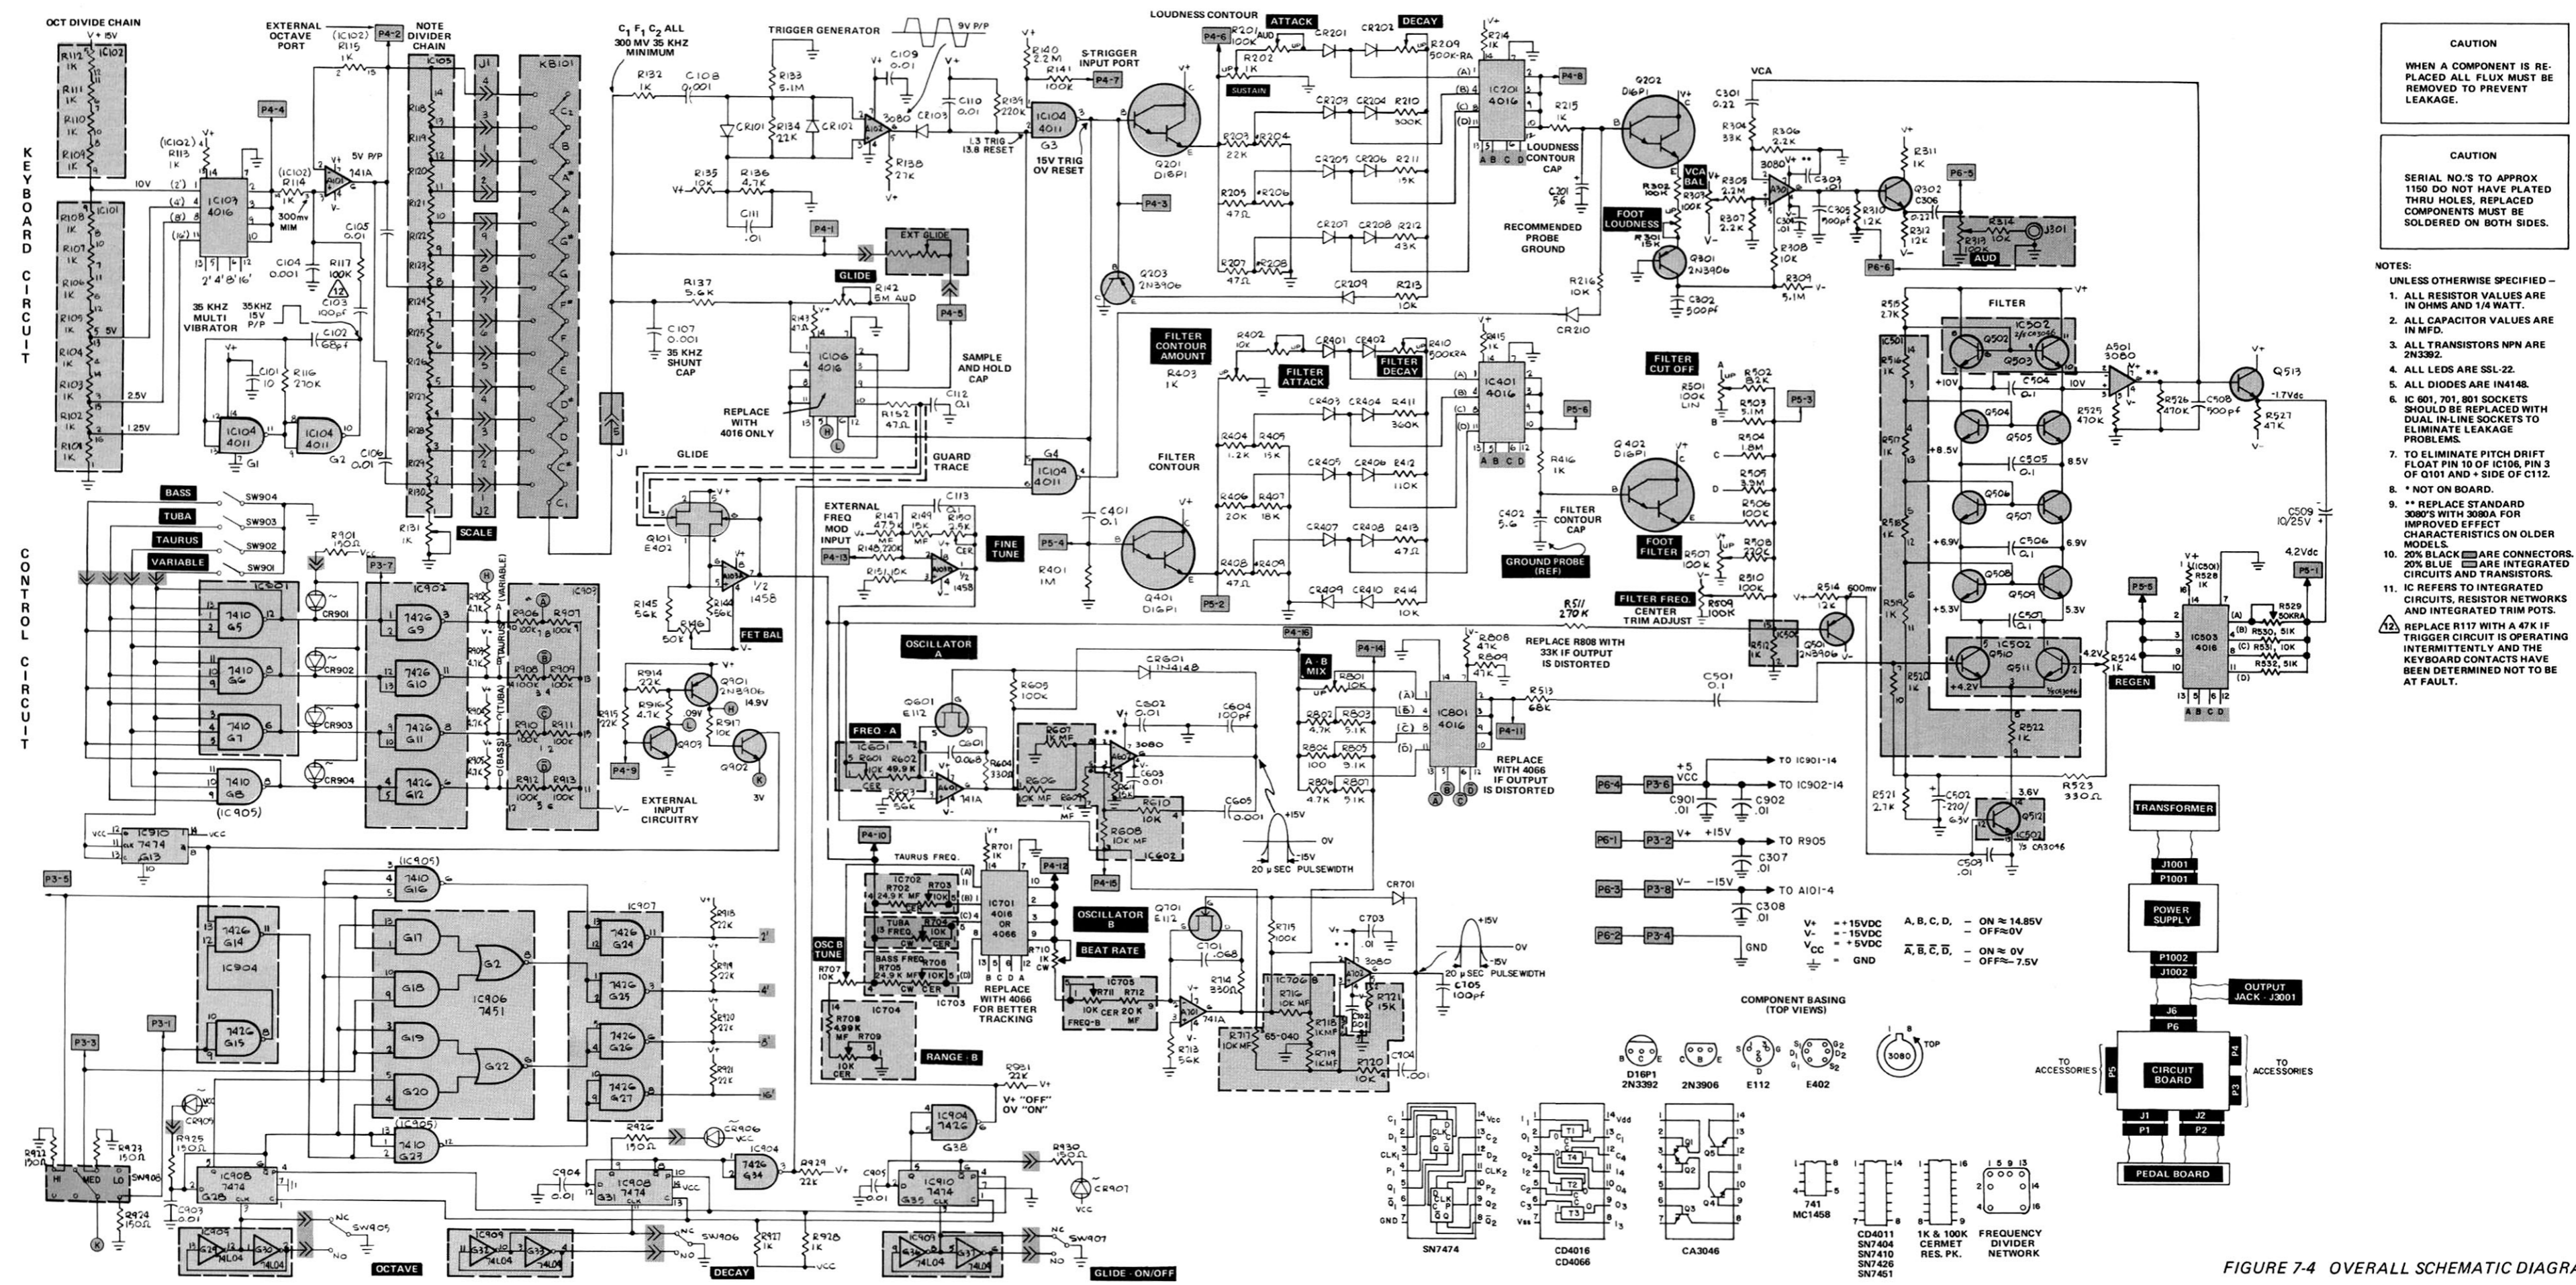
CAUTION
WHEN A COMPONENT IS REPLACED ALL FLUX MUST BE REMOVED TO PREVENT LEAKAGE.

CAUTION
SERIAL NO.'S TO APPROX 1150 DO NOT HAVE PLATED THRU HOLES, REPLACED COMPONENTS MUST BE SOLDERED ON BOTH SIDES.

SCHMATIC REPEATED ON REVERSE SIDE FOR SERVICE CONVENIENCE.
